Re: Failure Analysis of Aluminum Dumbbell
LIGO Account No 5F518, SEAL Job No 1086

Two aluminum dumbbell assemblies which were glued to a glass surface were sent to SEAL Laboratories to determine why the adhesive failed.

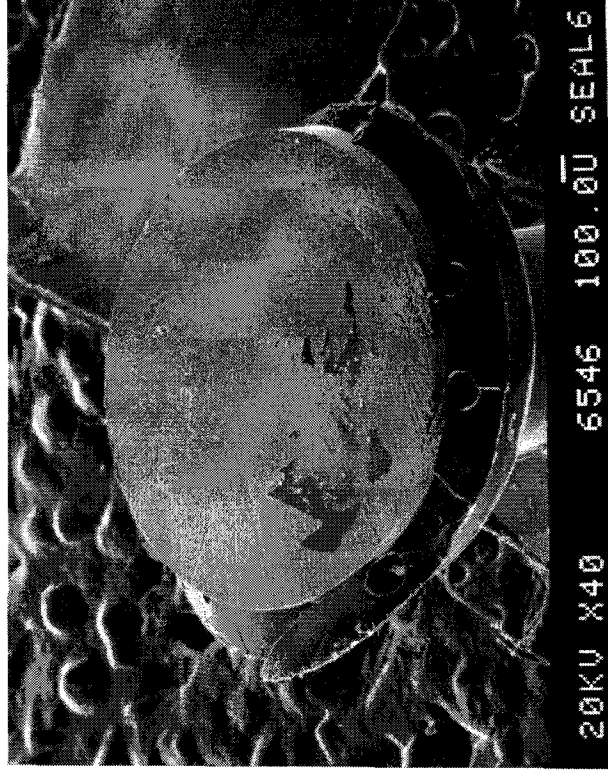
Figure 1. 40X SEM Image of Aluminum Dumbbell Bonding Surface
