LIGO *Core* Optics:

a decade of development and experience

W. Kells

LIGO Laboratory, Caltech

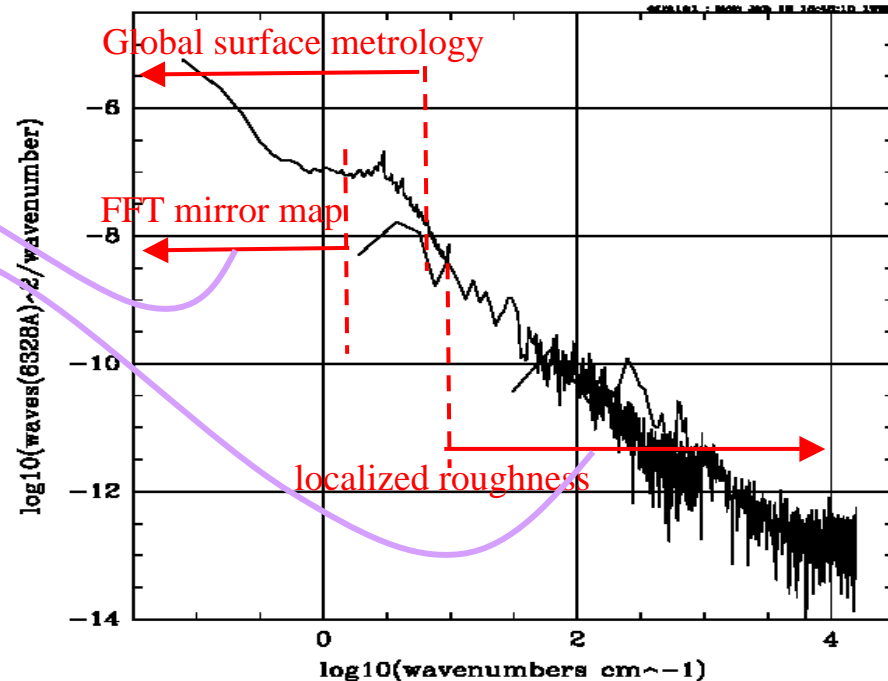
➤ Simulation (FFT) with Fab. Data:

- Figure= modal distortion
- Roughness= loss
- Low absorption= cold “start up”
- Witness sample reflectivity

Simulated G (at least: CR field not affected by degenerate recycling) far exceeds goals

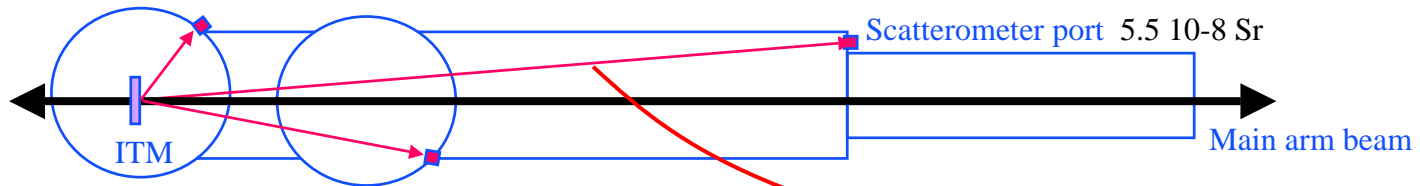
- Observed interferometer gains lower than Sim. predictions.
 - Consistent with 50-70ppm avg. additional loss per TM.
 - Consistent with “visibilities” (resonant reflectivity defect) of individual arms
- In situ studies: Some HR surfaces viewable @ 3 angles:

- Angular dependence more isotropic, “point like” than metrology prediction
- In situ observed scatter ~70 ppm mirr
- ~same level, character for every TM independent of history/cleaning.

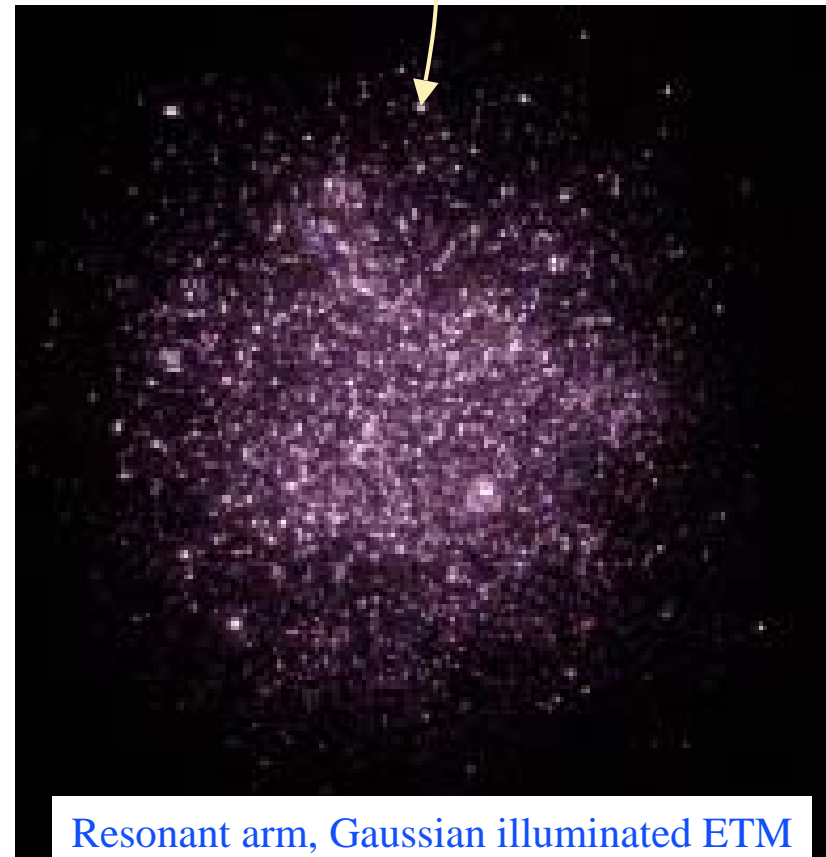
Is it just dust??

Resonant arm, Gaussian illuminated ETM

Analysis of the “Globular Cluster”

- This point defect background ~same for all optics.
- Diffuse (micro roughness) background contributes $< 1/3$ of total scatter.
- Other blemishes don't dominate total (?)
- Puzzle: Why these point defects missed in Lab. QA?

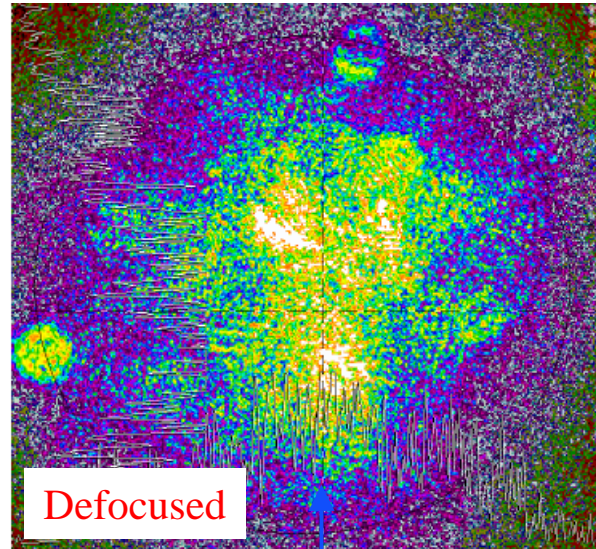
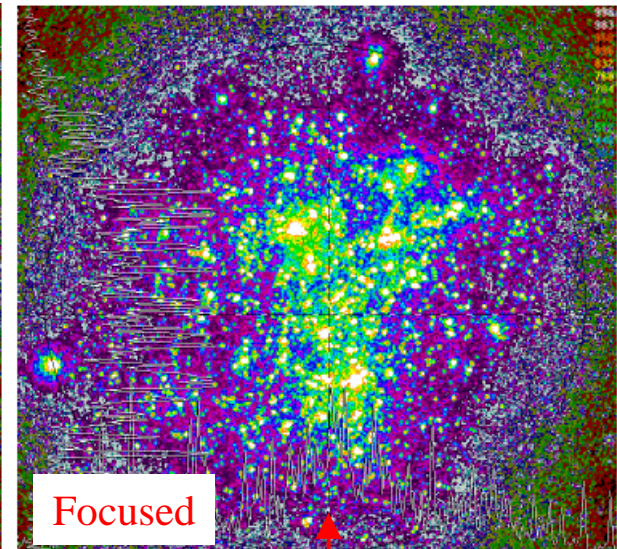
- Cleanest point scatter image: 2k ETMy:

- » Grab video stills for detailed analysis:

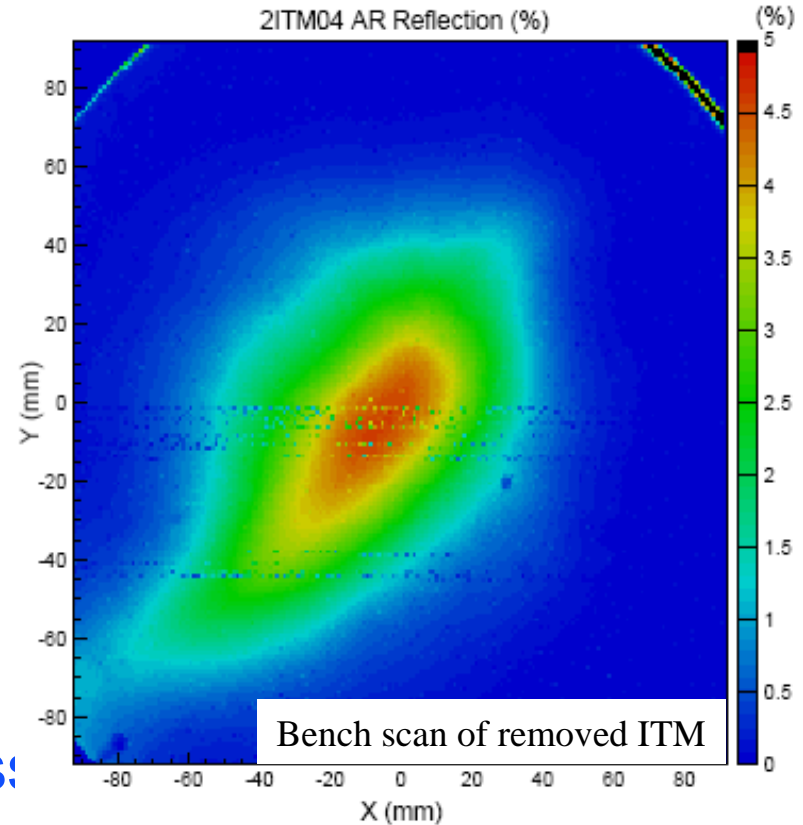
Coatings sensitive to handling

- For several years Hanford 2k performed poorly

- » X arm visibility (resonant reflectivity) poor
- » Ugly recycling cavity “mode” pattern
- » Excess dark port contrast
- » More dramatic: unlocked arm cavity $|r| \neq 1$

- Found: AR coating anomaly

- » Hypothesis: extended harsh cleaning of surfaces had etched coating layers.

Lesson: coating sensitivity to thickness change (confirmed by model).

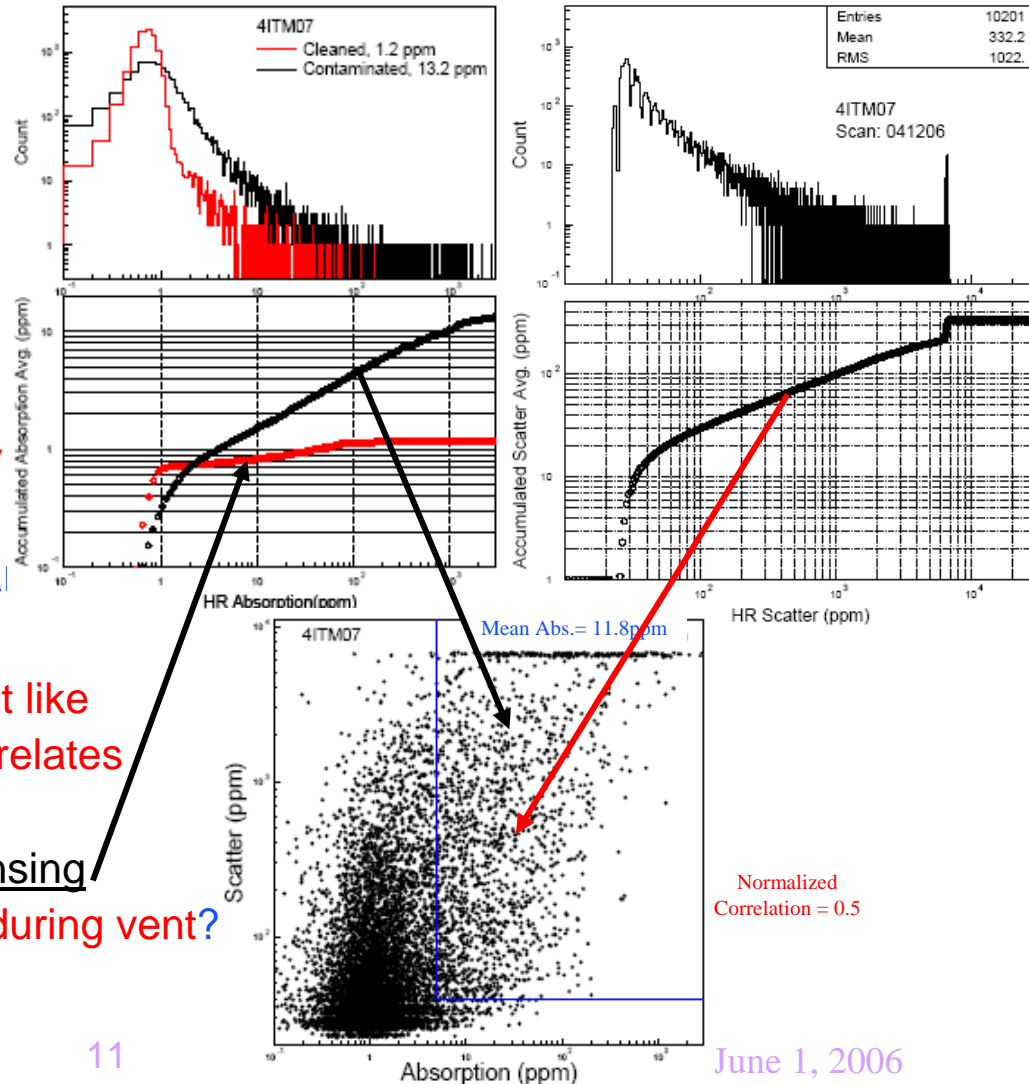
Example: What is anomalous contamination on H1 ITMs?

- Absorption is lumpy but not point like
- Scatter also anomalous and correlates well spatially with absorption
- Easily removed by surface cleansing
- Fine absorbing dust, sucked in during vent?
